Landslide Risk Assessment for Saint Lucia's Primary Road Network

Hurricane Tomas Rehabilitation and Reconstruction
Final Feasibility Report
September 2013

Government of Saint Lucia

Ministry of Infrastructure, Port Services and Transport
Union Office Complex
Castries

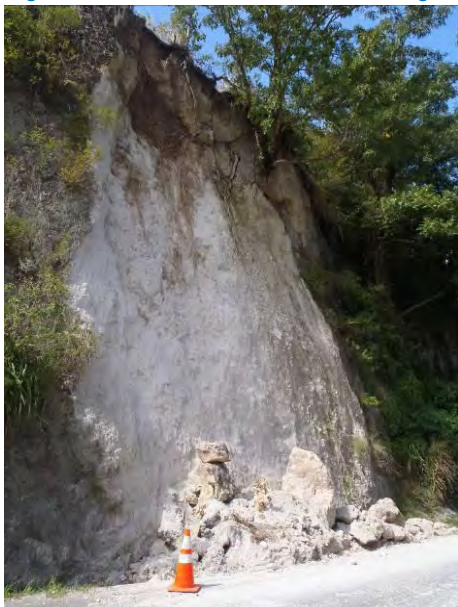
Figure 1.2: Small rock fall onto the highway in zone 7

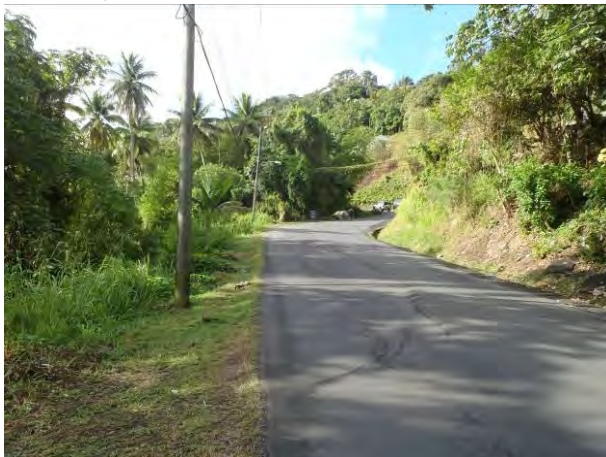
Figure 1.3: Arcuate crack and depression in road caused by landslide at Ti Colon (Ch 22955 – 23000 SB)

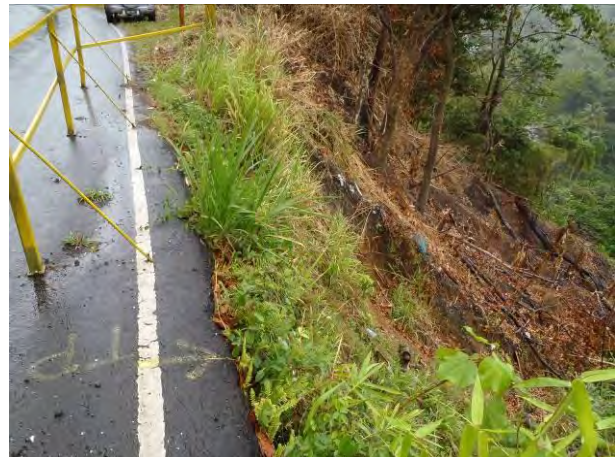
Figure 1.4: Shallow slope failure along road at Site 9 on the Barre de L'isle (Ch 125295 – 125340 WB)

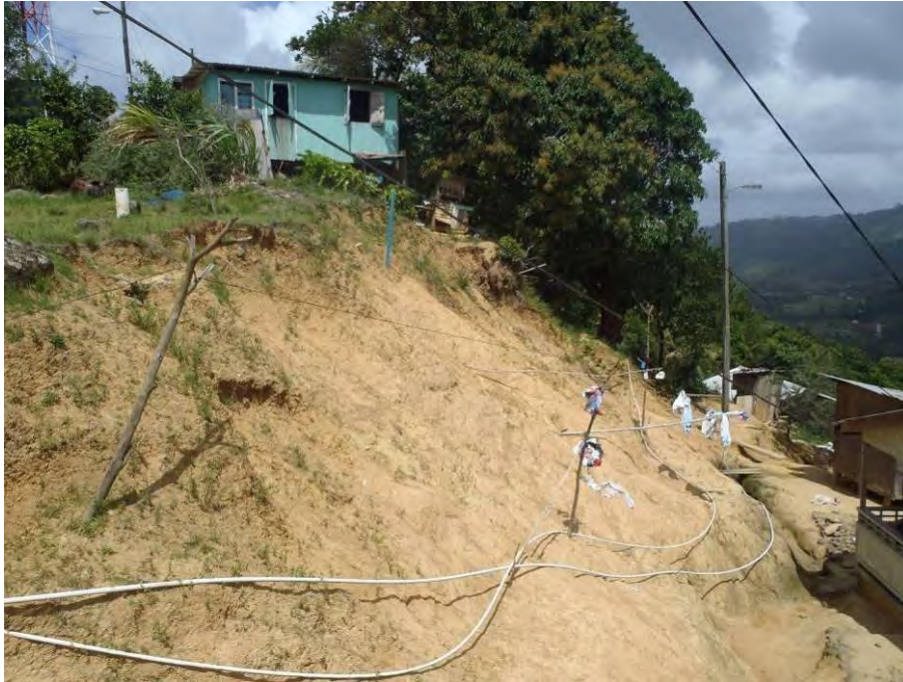
Figure 2.2: Installation completed for 1998 WEMP project recently exposed by a landslide

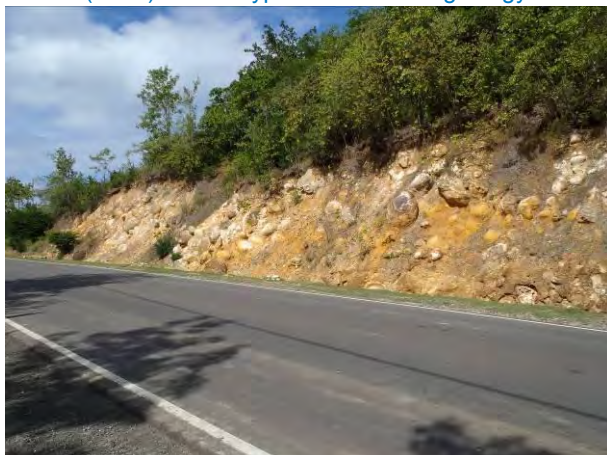
Figure 5.4: The Millennium highway rock slope failure in zone L (north) rockfall type related to the geology.

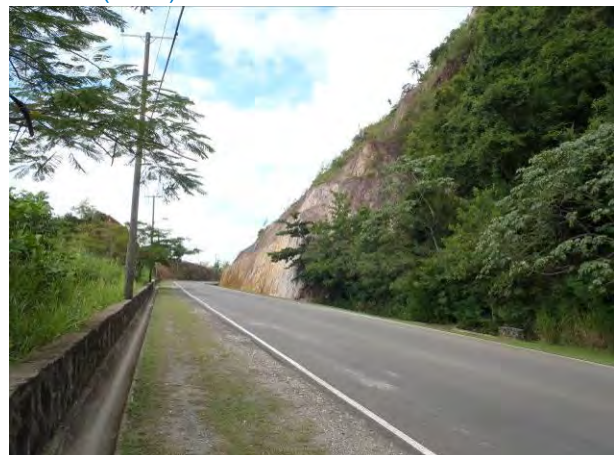
Figure 5.5: The Millennium Highway rock slope failure in zone LL (south) rockfall related to discontinuities

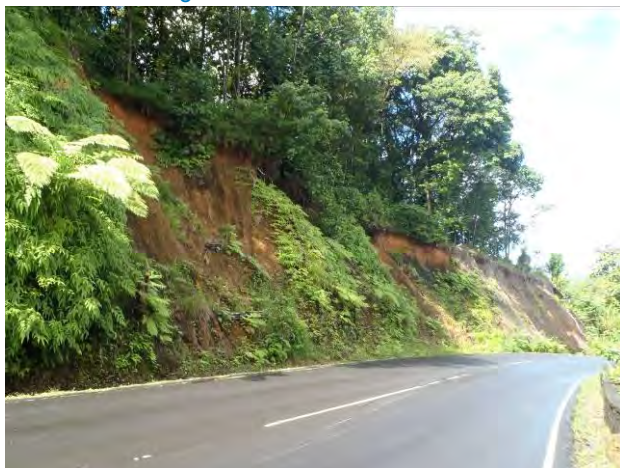
Figure 5.6: Translational slides on the west of the Barre de L'Isle resulting in debris on the road

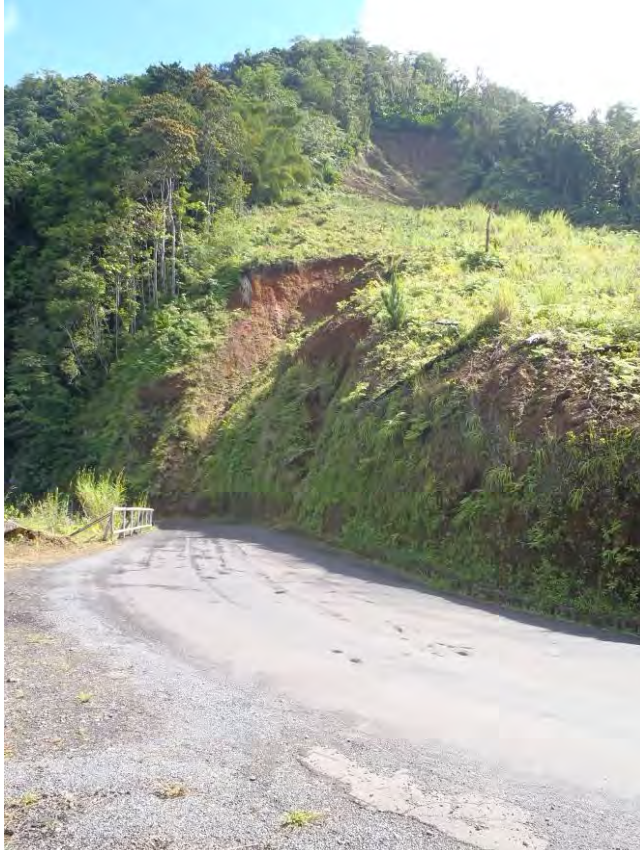
Figure 5.9: Recent debris flow - Colombette

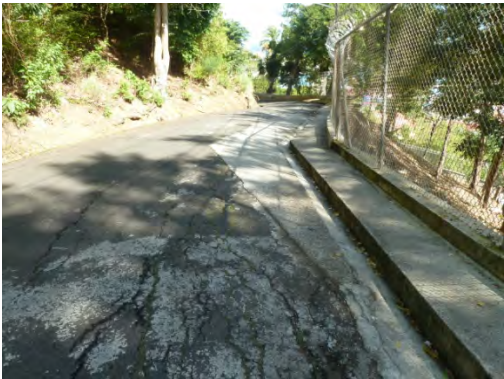
<p>Repairs at the start of the road have been carried out by the landowner:</p>

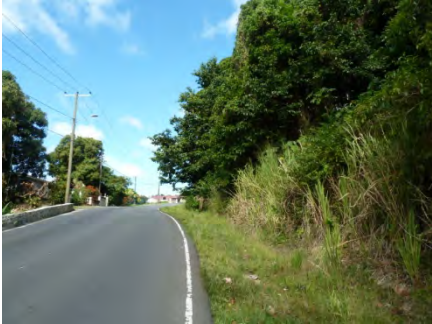
Item	Text	Action on
	<p>However there is one location by the Eudovic Art Studio (E508413, N1546456) where there are regular slips. This fails about 3 times a wet season and will costs EC\$7,000-\$10,000 to clear each time. Generally cleared within 1 day.</p>

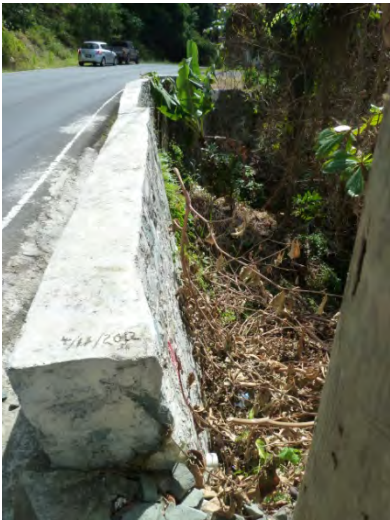
<p>The following section near Goodlands Road (Coca Cola hut)(E508231, N1546697) suffered a vertical failure in 2005. The retaining wall has been repaired and no movement has been noted since.</p>

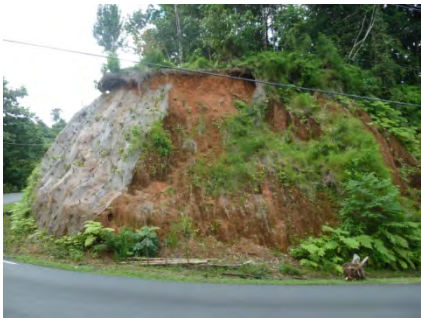
<p>There is one section of rock netting in this section which has been installed by others and it is believe that the Special Project Unit (SPU) is carrying out the monitoring:</p>

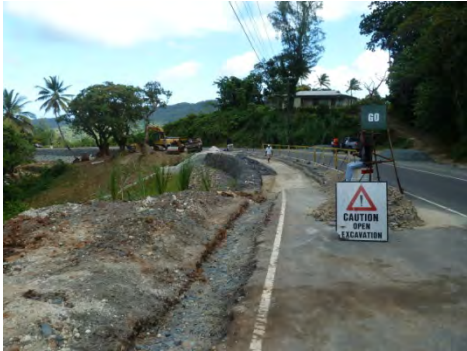
Item	Text	Action on
	<p>concrete drain has helped but the whole area is still moving. Special Project Units (SPU) is monitoring the area.</p> <p><i>Location – GPS 19 (E 513131, N 1539462)</i></p>

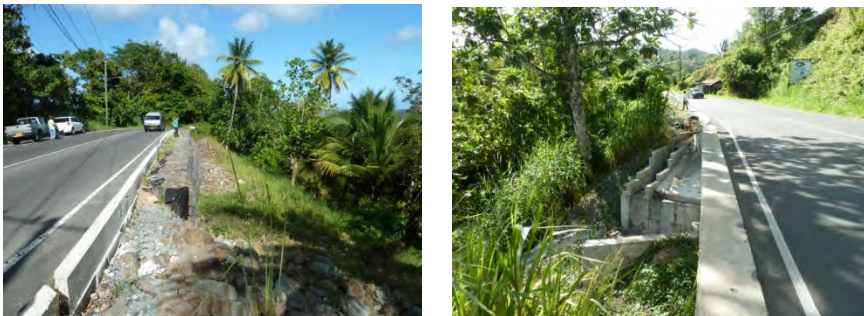
<p>This is one of the major repair locations. Causes of slide include uncontrolled run-off, poorly compacted fill and lack of drains. This took approximately 1.5 weeks to clear. Interventions include gabions walls, shallower slopes, cascade drains and the use of Vetiver grass. This is WB/CDB funded and is being monitored by SPU. Design details and costs are requested.</p> <p><i>Location - GPS 20 (E513787, N 1539593)</i></p>

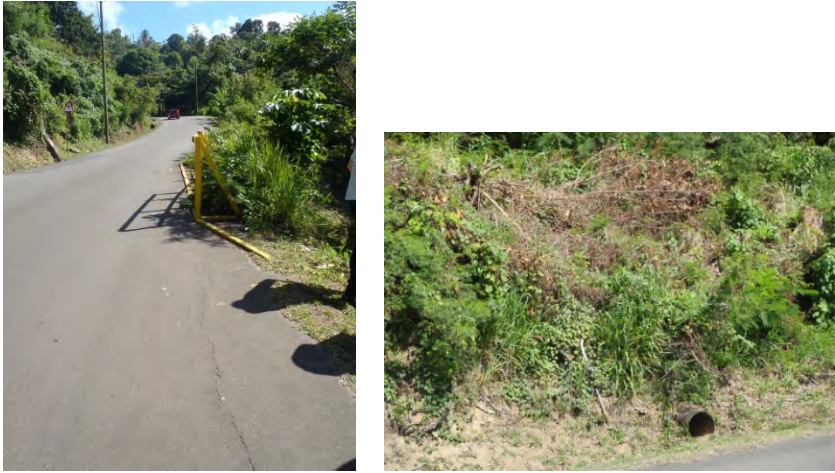
Item	Text	Action on
	<p>along an existing retaining wall is holding up well.</p>   <p><i>Location – Wall 4 La Croix, GPS 31 (E507146, N 1543983)</i></p>

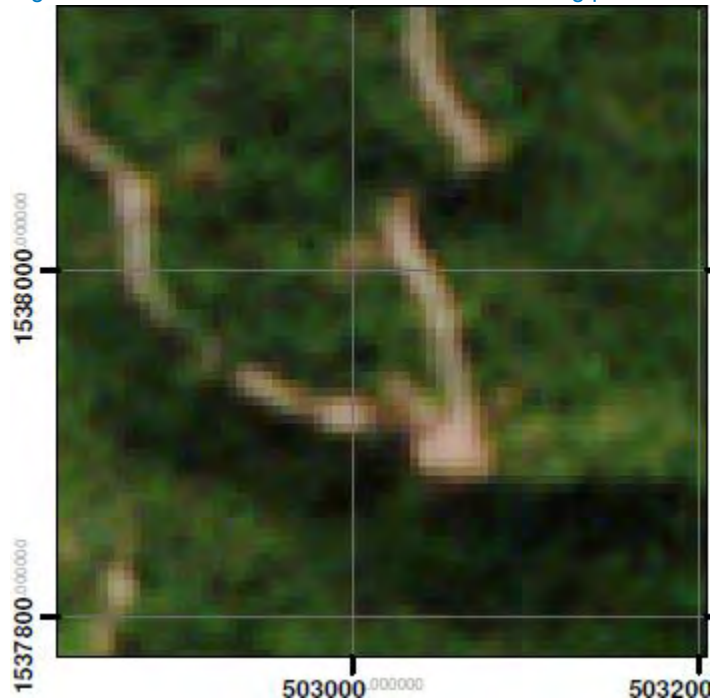
Figure H.31: Location after Hurricane Tomas showing probable debris covering the road
