Landslide Risk Assessment for Saint Lucia's Primary Road Network

Hurricane Tomas Rehabilitation and Reconstruction
Final Feasibility Report
September 2013

Government of Saint Lucia

Ministry of Infrastructure, Port Services and Transport
Union Office Complex
Castries

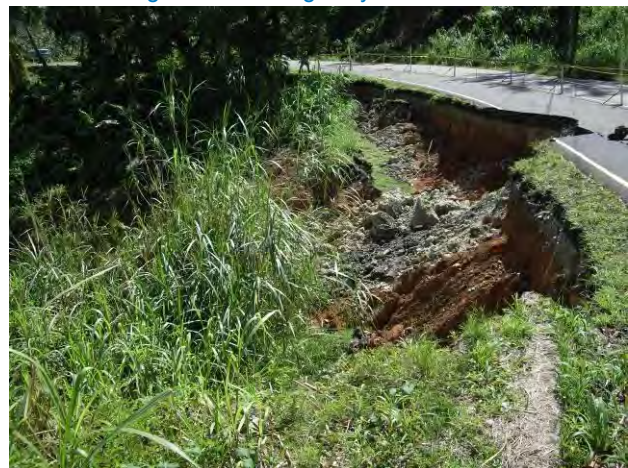
Figure 5.7: translational slide on top of the Barre de L'Isle showing loss of carriageway

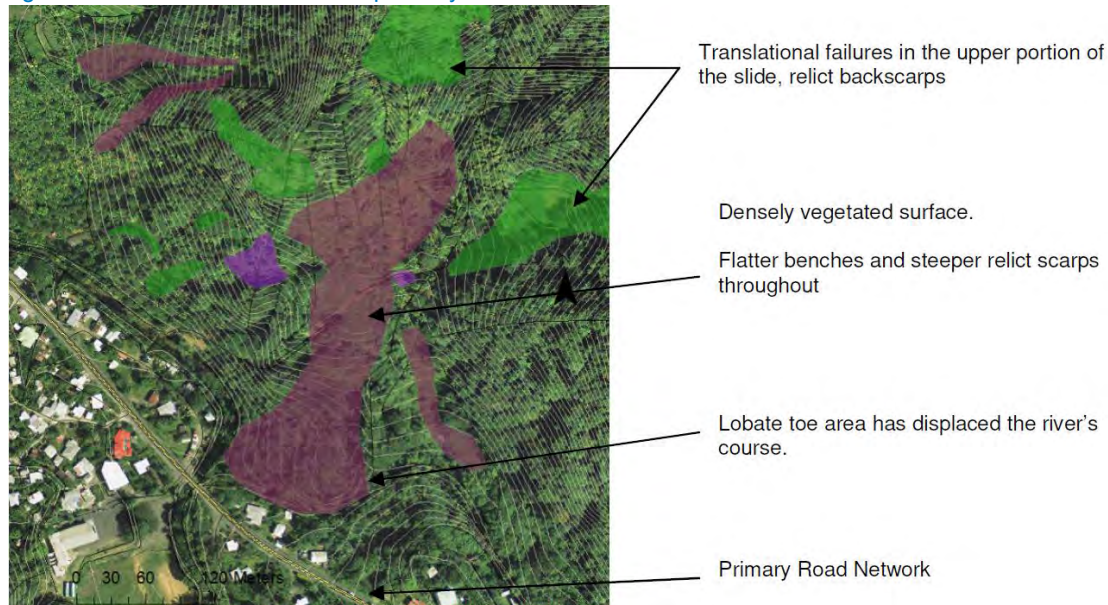
Figure 5.8: Historic debris flow – possibly related to the Ravine Poisson slides that occurred in 1938

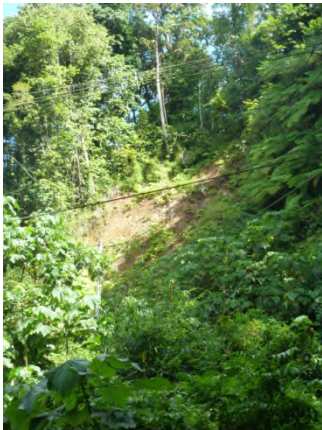
<p>Barre De L'Isle</p> <p>This covers the section to the top of Barre De L'Isle (Barre De L'Isle Reserve sign). In general slides along this section are more significant and take 1-2 days to clear. During Tomas these were exacerbated. Following Tomas there are significant areas of exposed rock. There are several springs along this section:</p>

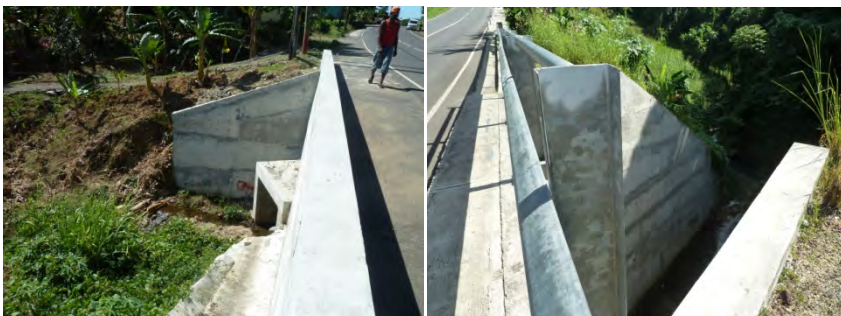
Most of the culverts along this route are ARMCO and have reached the end of their life and are beginning to cause problems such as depressions in the road. Where there are slopes along the route they are generally bedrock so this section only has v minor slips or rockfalls that do not affect the road function.

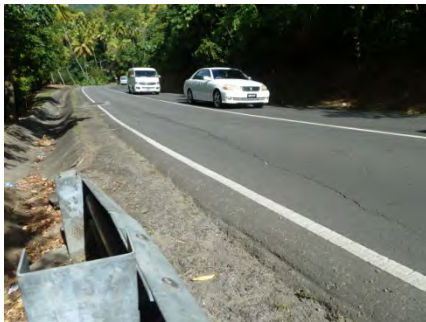
All along this section from Soufriere to the Stonefield Estate turn off is showing signs of distress and pavement creep. There is a lack of drainage channel behind the safety fence along this side and it is causing erosion. <i>Location – GPS 42 (E 501718, N 1530837)</i>

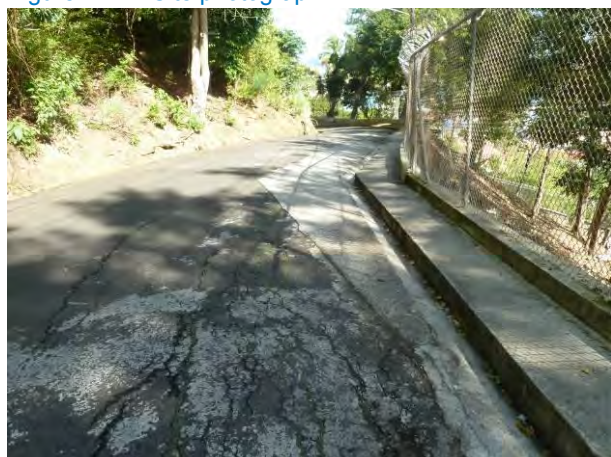
Figure H.2: Site photograph

One-way single lane roadway with extensive tension cracks and displacement parallel to the pavement. Drainage is mainly at the toe of the slope along the inner carriageway.

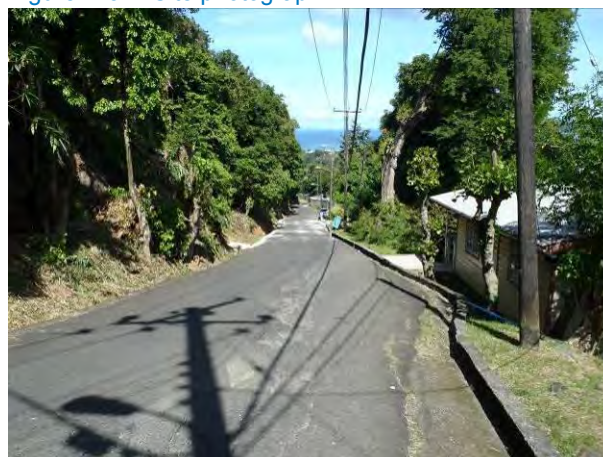
Figure H.3: Site photograph

Tension cracks in pavement as a result of creep movement appeared more than 15 years ago. Landslide activity accelerated during Hurricane Tomas when sections of the outer carriageway collapsed and slope failures exposed the bedrock.

Residual soils and Andesite rock outcrops exposed on slopes along the roadway observed from site walkover. No knowledge of subsurface investigations having been conducted at the site.

- Seal tension cracks on road surface;
- clear existing drains.

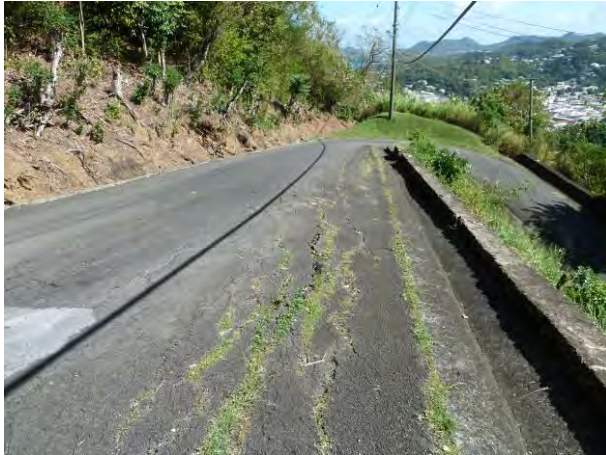
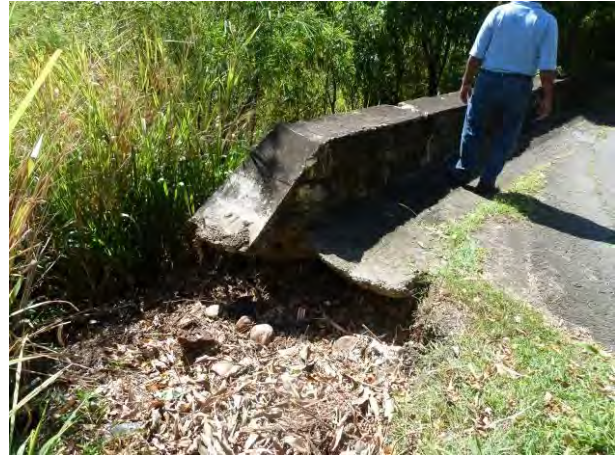
Figure H.5: Site photograph

Steep and tight one-way single lane roadway with extensive tension cracks and displacement parallel to the pavement. Retaining walls below slope show evidence of movement. Drainage is mainly at the toe of the slope along the inner carriageway.

Tension cracks in pavement as a result of creep movement appeared more than 15 years ago. Movement accelerated during Hurricane Tomas. The area has been monitored for surface movement in the past however no records are available.

- Seal tension cracks on road surface and in time repave entire road;
- clear existing drains.

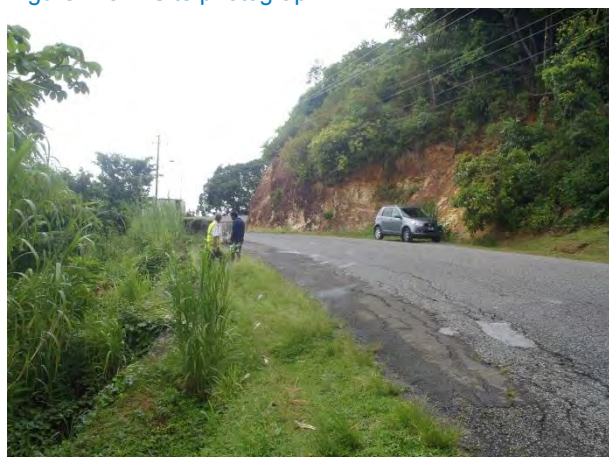
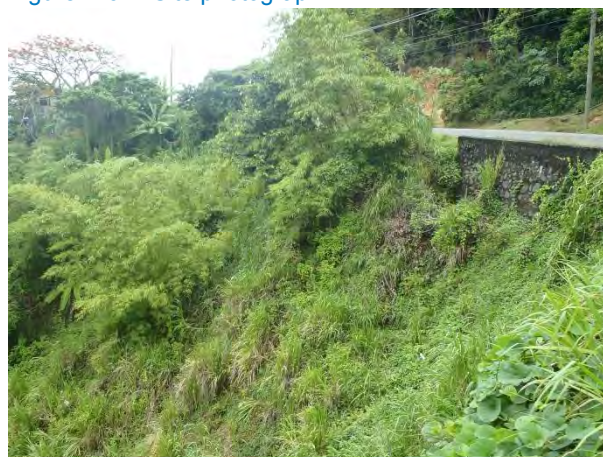
Figure H.8: Site photograph

Currently a two lane road, however the width of the road is reduced owing to historical movement. An existing wall below the road has moved and concrete bollards have been installed where settlement and cracking of the pavement has occurred. The slope below is steep and vegetated, leading to a gully. The slope above has had shallow failures depositing material on the road and blocking drainage.

At the time of writing, no record of the history of movement is available. It is understood the original movement occurred several years ago and minor pavement degradation has occurred since.

No knowledge of subsurface investigations having been conducted at the site. The failed slope above the road has a backscarp of very weak cream and purple highly weathered rock, probably Andesite.

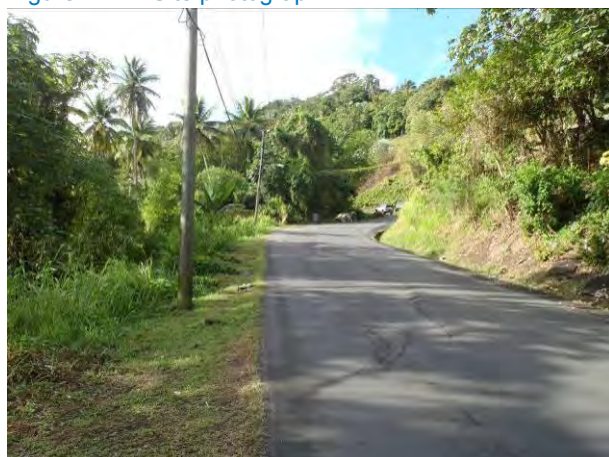
Figure H.11: Site photograph

Roadway with arcuate cracking affecting half of the width of the road. Slope below is steep and highly vegetated. An existing gabion structure is present over part of the site but it is difficult to see the condition of the structure.

No record of this history of movement is available. Road has settled approximately 50mm in places

- Seal tension cracks on road surface and in time repave entire road;
- clear existing drains.

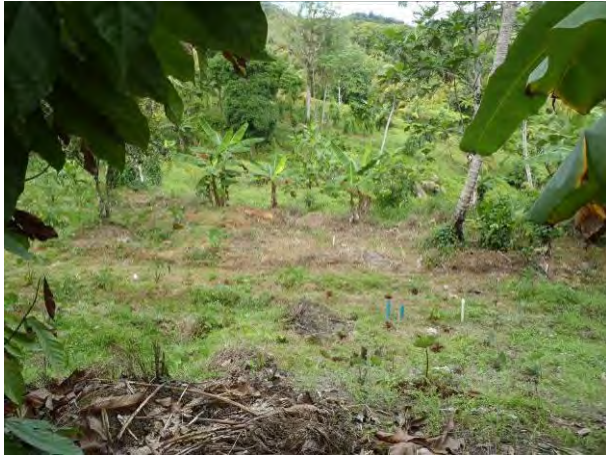
Figure H.13: Site photograph

Initial slope movement observed in July 2005 following a rainstorm. Other parts of the island experienced landslips including the Windjammer Landing Beach Resort which experienced a mean monthly rainfall of 199 mm for July 2005. Subsequent slope movements at occurred during October 2008 and during Hurricane Tomas.

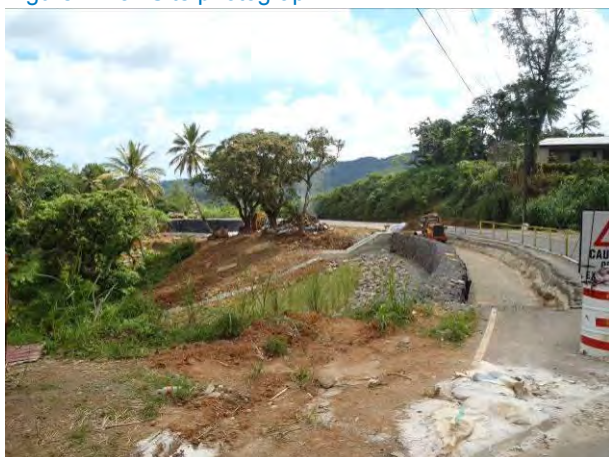
Figure H.15: Site photograph

Two failures that are currently being remediated. Some features identified during site visits including geomorphology, location of drainage channels and possible backscarps suggest the slide may be deep seated. This is considered unlikely however the available ground investigation will be investigated to confirm that the failure is shallow and therefore the current remedial works are appropriate.

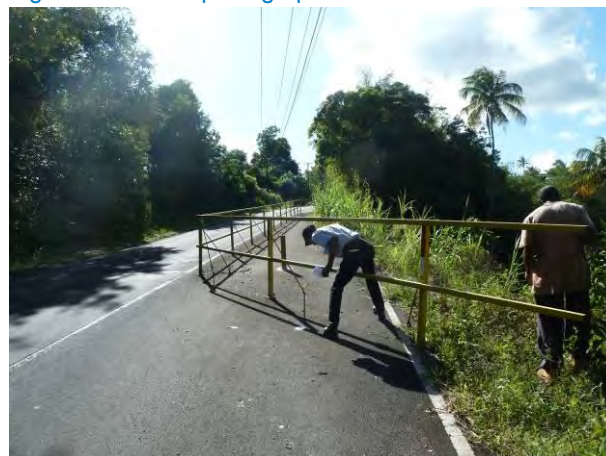
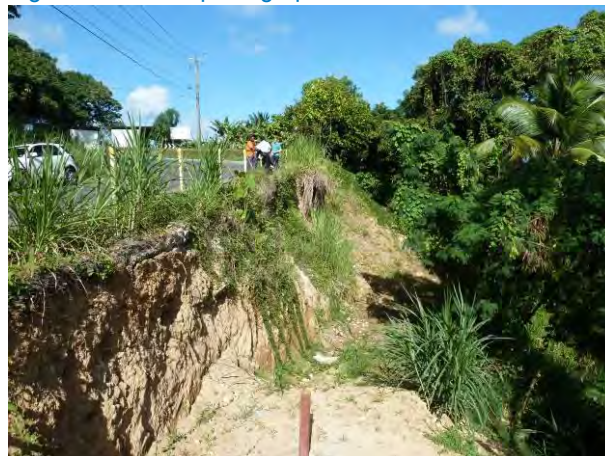
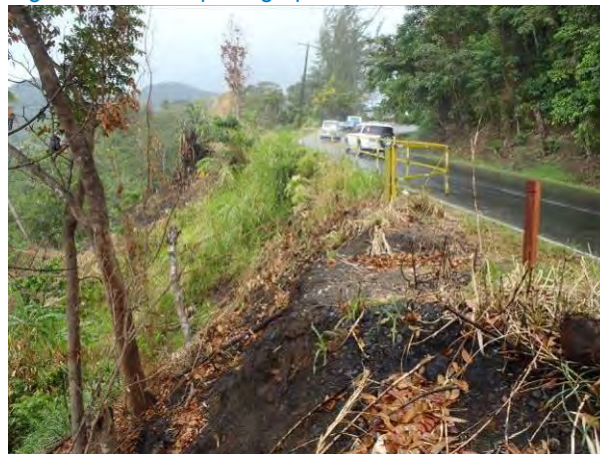
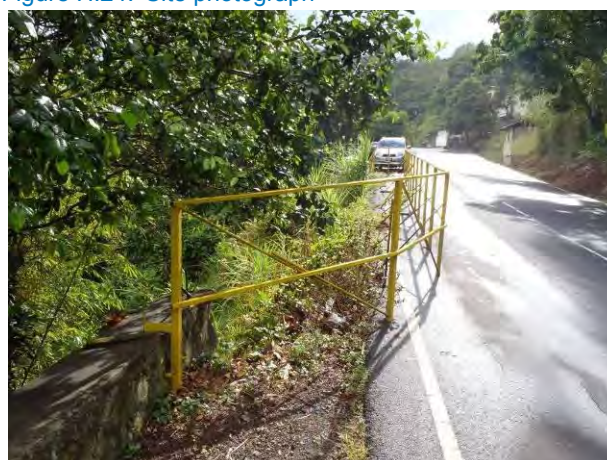
The FDL report discusses the failure mechanism at each of the sites. FDL consider prolonged rainfall during Hurricane Tomas lead to a reduction in the shear strength of the soil such that it became fluidised and easily eroded. Runoff became focused at locations it could flow over the edge of the road on to the down slope causing erosion and concentrated infiltration.

FDL describe the physical characteristics of each site. The four sites have steep sections immediately below the road, decreasing towards the toe of the slides. FDL consider the plane of weakness to be coincidental with the post failure ground surface.

Trintoplan discuss potential remediation measures and recommend drainage improvements and a structural solution at each site. The structural solution recommended at sites 9 and 10 is a retaining wall founded on a deep augered pile foundation. A range of options is suggested for sites 6 and 7, including a proposed reinforced earth structure.

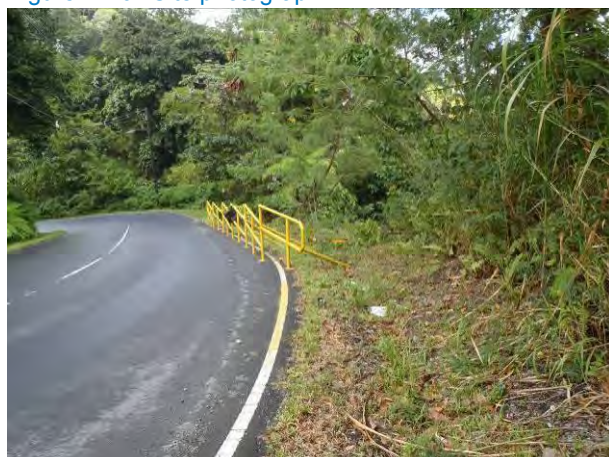
Figure H.26: Site photograph

Steep slope below road. Existing masonry retaining wall damaged above ground and possibly damaged below ground but difficult to see. Northern end has 3-4m of collapsed wall which is being undermined. Drainage is currently partly channelled towards the failure and drains are not lined on this side of the road.

Understood to have occurred during Hurricane Tomas.

- Improve drainage to prevent infiltration behind the remaining retaining wall and prevent surface flow off the slope beneath the retaining wall and in failed area.

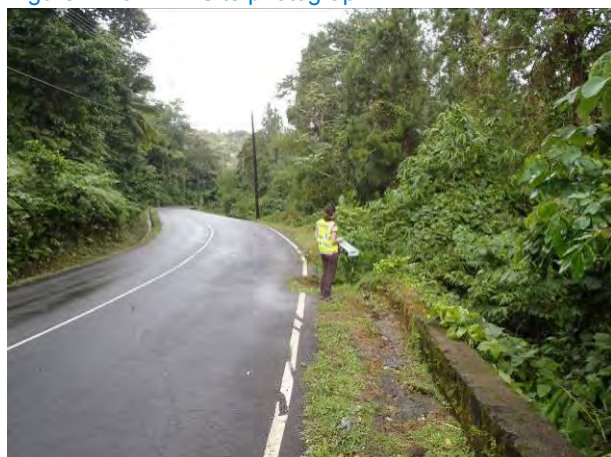
Figure H.28: Site photograph

Small stretch of road with small failed area at edge of retaining wall encroaching on the road. The failed area is associated with a failed section of retaining wall. Steep slope below. Water being directed onto the failure by current drainage layout.

- Redirect drainage to prevent discharge directly onto failed area.

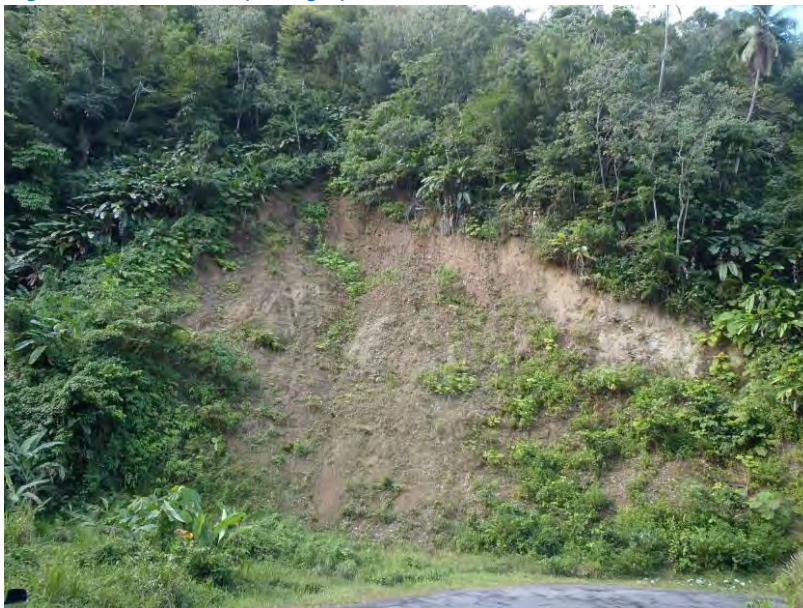
Figure H.30: Site photograph

The failure is approximately 25m across at the base, and the top of the failure is estimated to be around 15m above road level. The depth/thickness of the failure appears to be less than 2m.

The failure is above the road and the site is understood to have failed during Hurricane Tomas and completely blocked the road as shown in Figure H.31. DeGraff (1985) records a failure just west of the location.

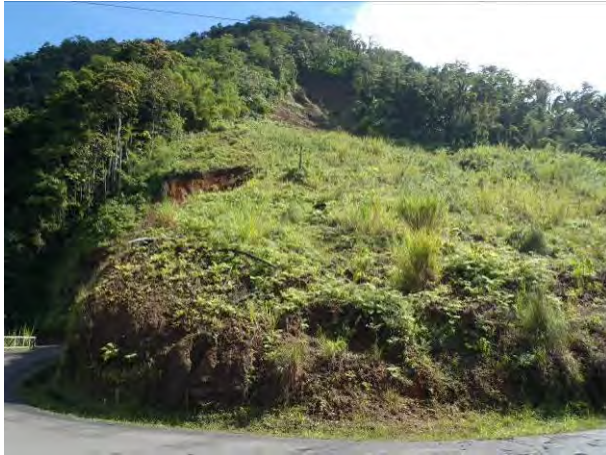
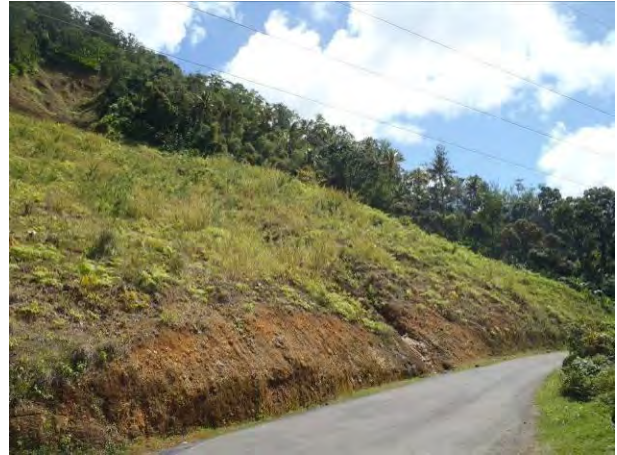
Figure H.34: Site photograph

Very rapid debris avalanche triggered by intensive rainfall and increased pore water pressures in the subsoils. The moving soil mass flowed over the main roadway without undermining any section of the road. The debris flow caused loss of life and property. Exposed upper backscarp slope expected to collapse onto lower slopes with time but not expected to reach the primary road

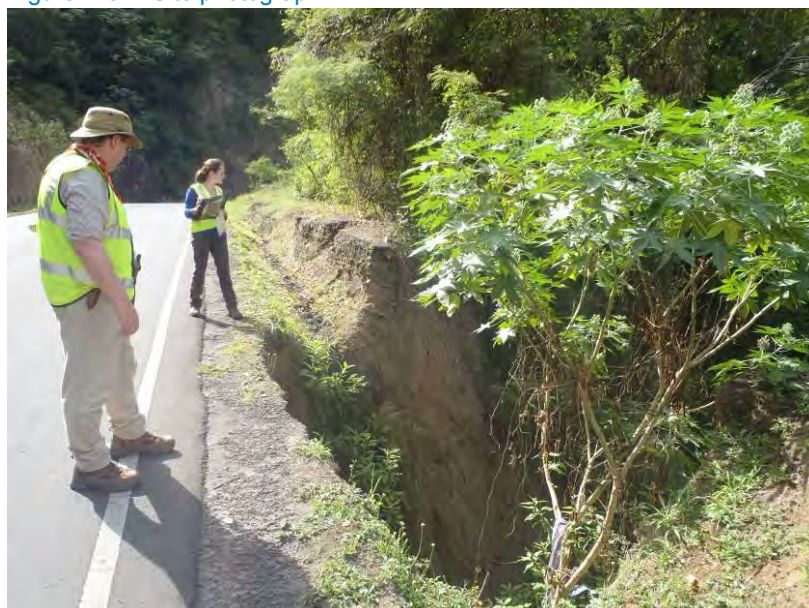
Figure H.37: Site photograph

A failure approximately 5m wide below the road. Failed slope is steep and drainage is being directed onto the slope.

The slope is understood to have failed during Hurricane Tomas.

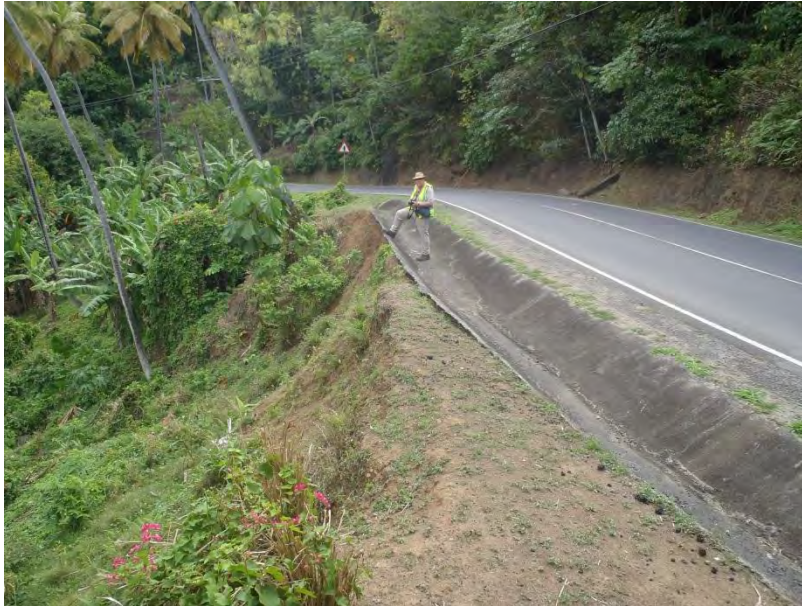
Figure H.39: Site photograph

Failures occurring on slope below road, undermining drainage.

The slope is understood to have failed during Hurricane Tomas and has regular shallow movements associated with rainfall events.

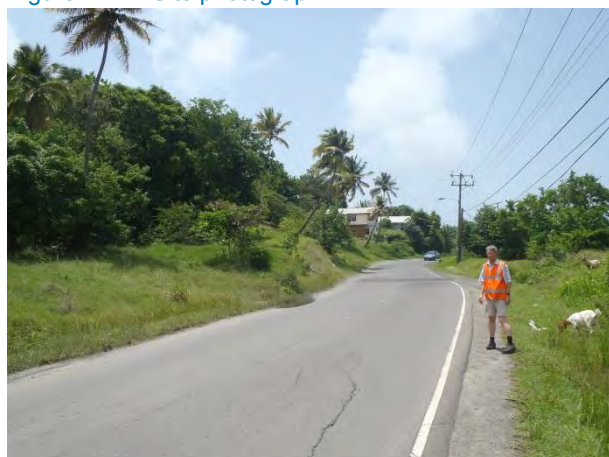
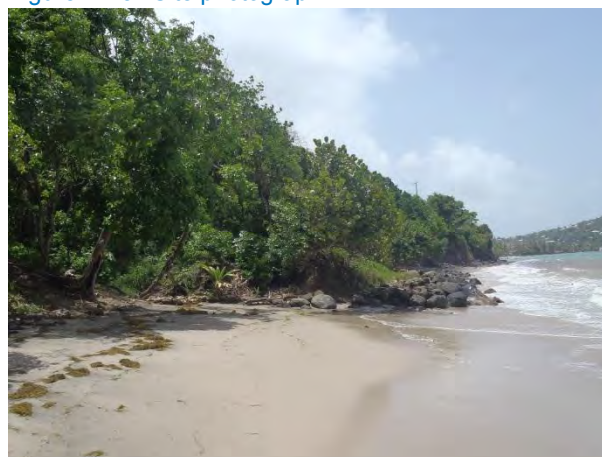
Figure H.42: Site photograph

Relatively shallow, vegetated slope above road and vegetated toe of slide extending to sea shore. Zone approximately 40m wide where pavement settles small amounts. Some rock (toe protection) appears to have been placed along the shoreline.

Pavement settles over a section approximately 40m wide. History of movement not known.
